REPORT No. 79-139

AIR NEW ZEALAND
McDONNELL-DOUGLAS DC10-30 ZK-NZP
Ross Island, Antarctica
28 November 1979

OFFICE OF AIR ACCIDENTS INVESTIGATION
MINISTRY OF TRANSPORT
WELLINGTON

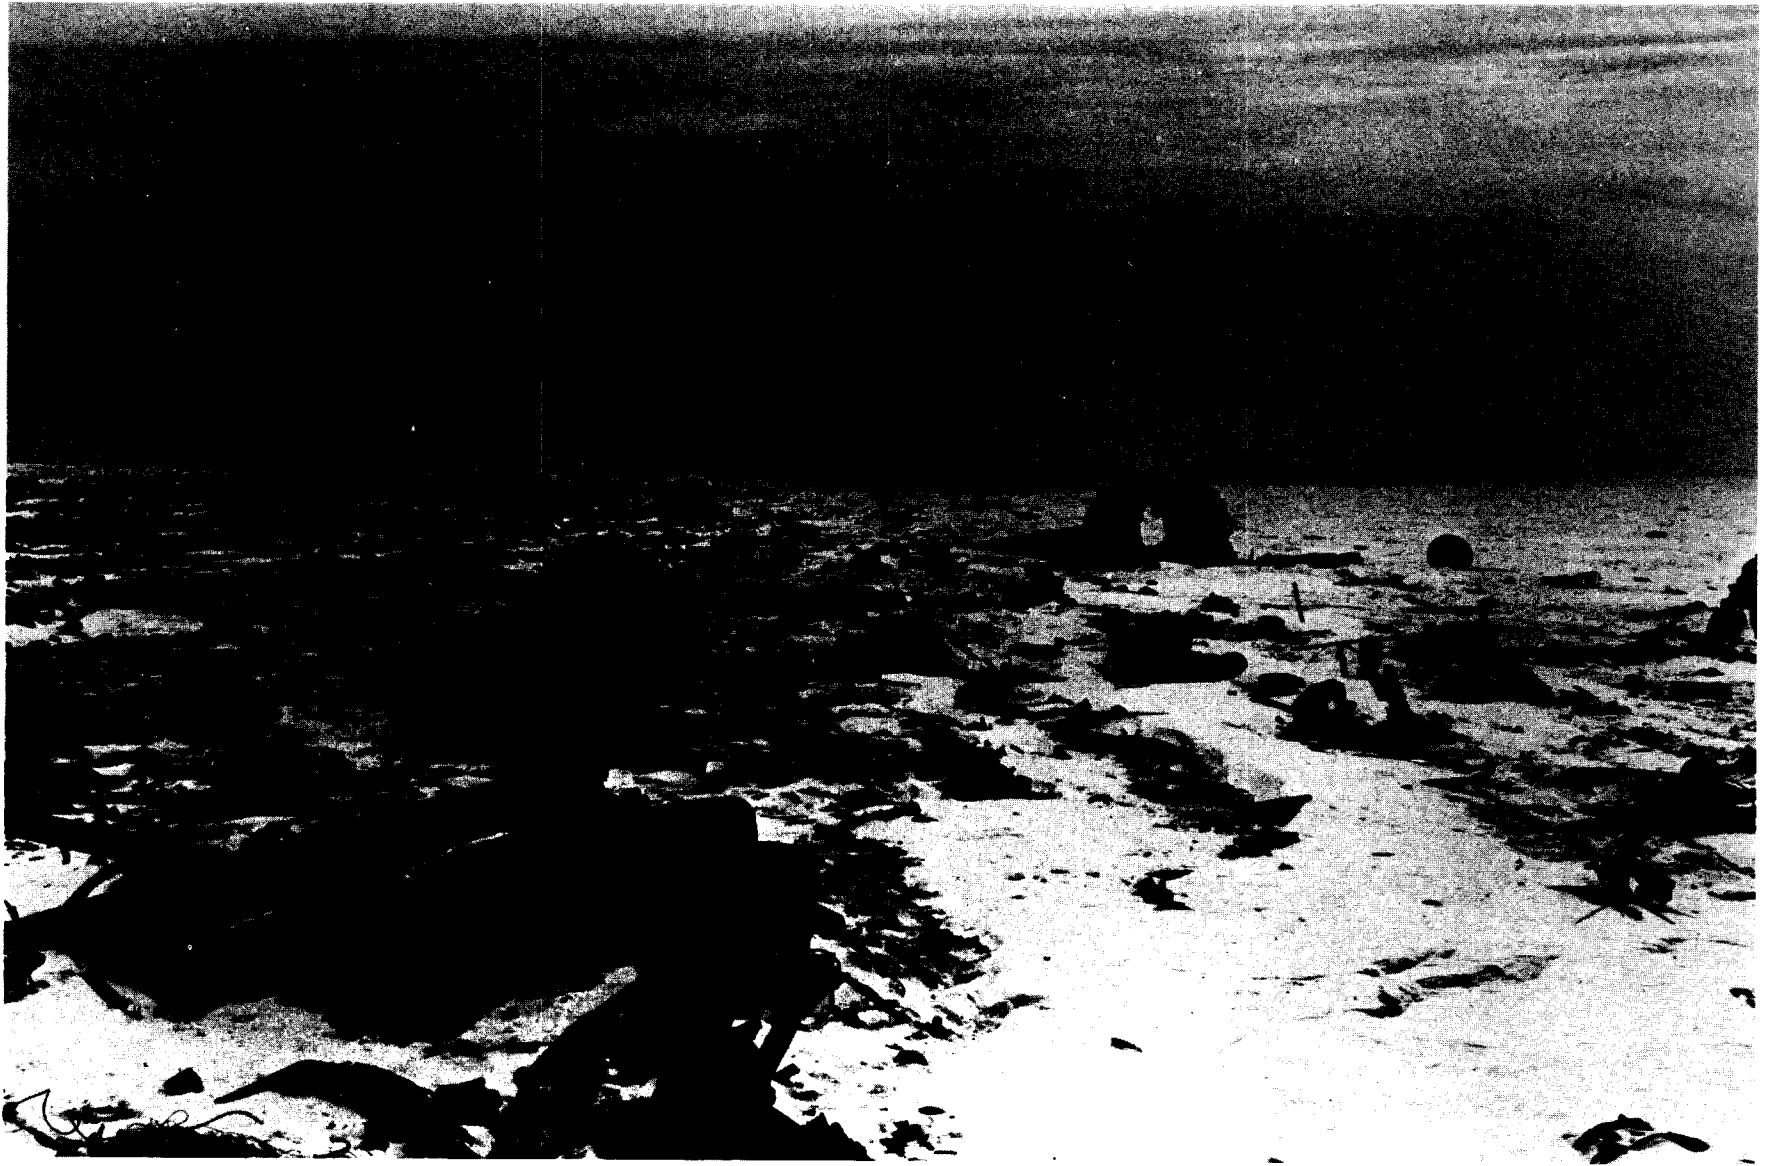
1.12.10 The largest portion of the aircraft remaining was the complete constant section length of the damaged cabin section which remained attached to the wing's centre and inboard sections. This portion was at the forward end of the wreckage trail and was involved in a persistent, intense and deep seated fire.

FIG 1 WRECKAGE OF ZK-NZP LOOKING NORTH OVER LEWIS BAY

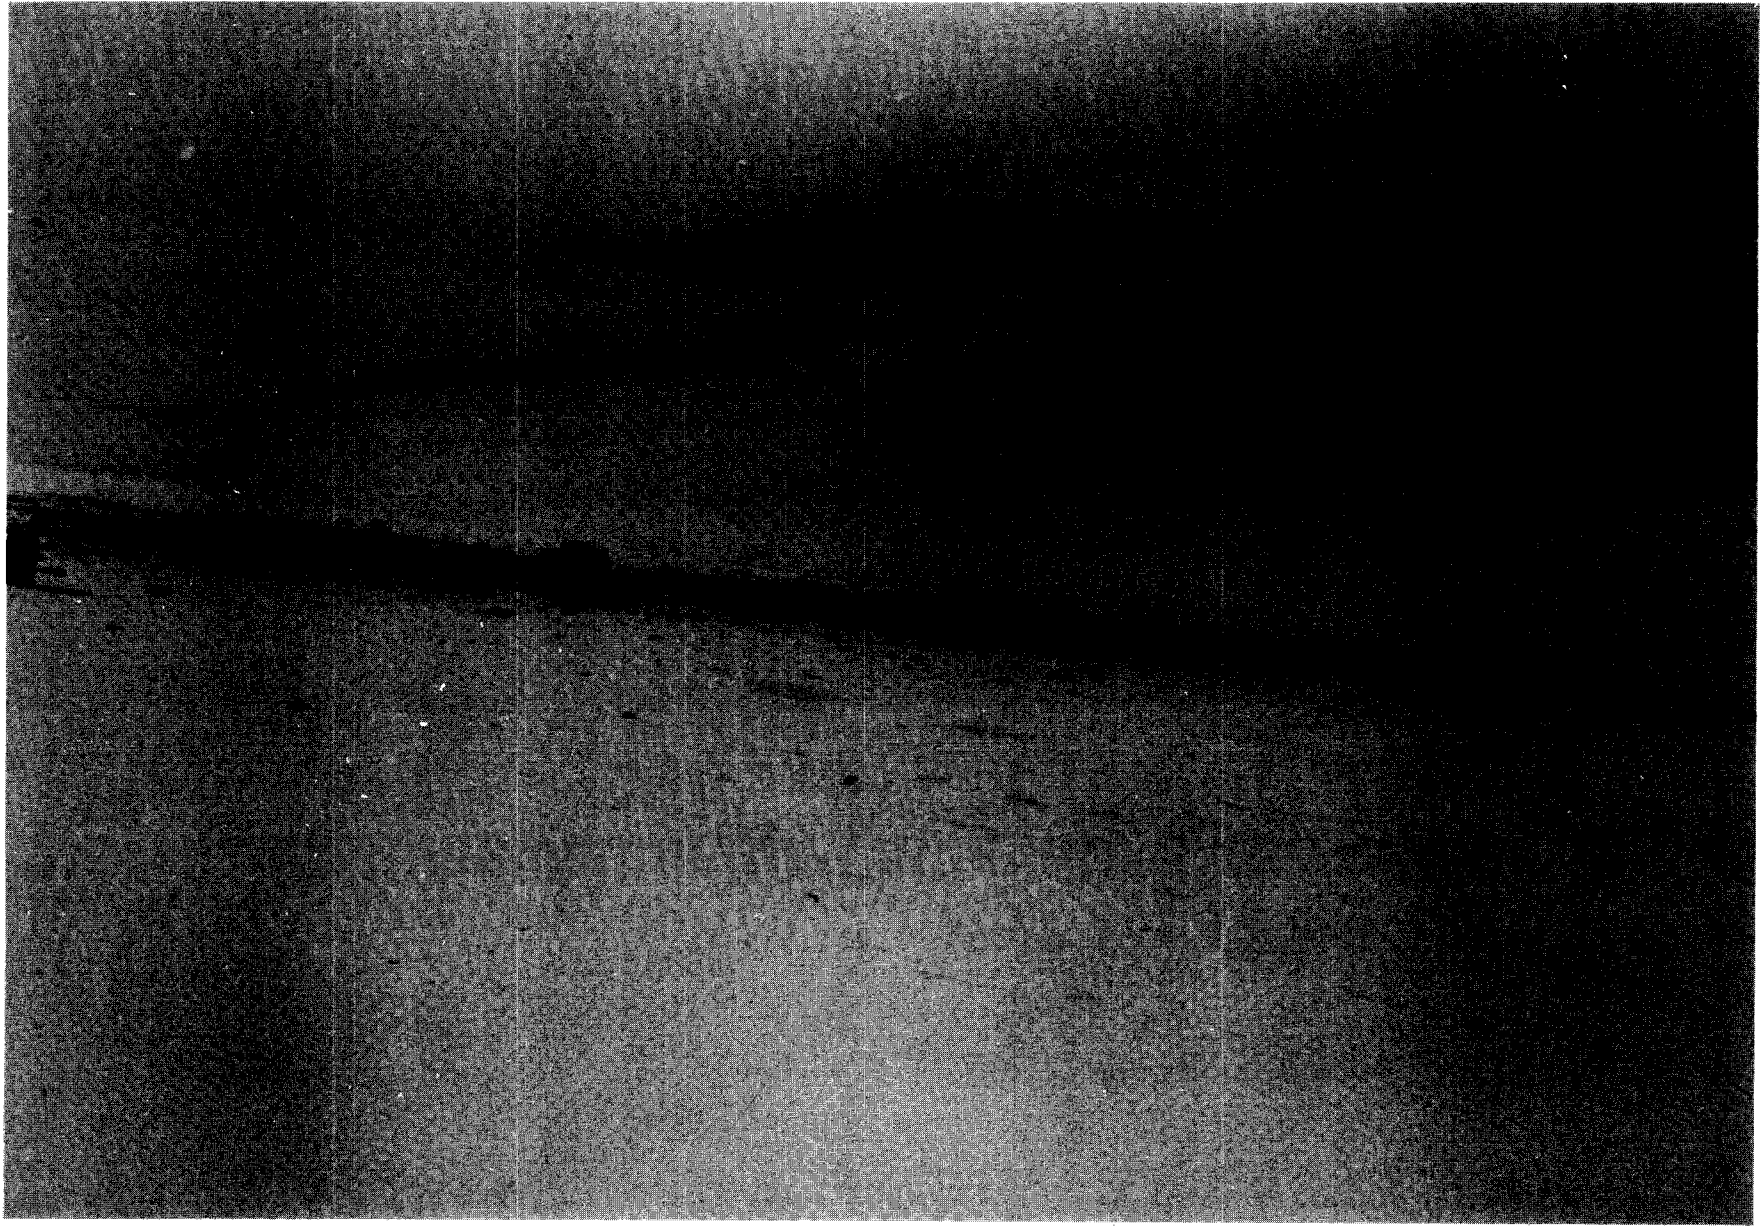
FIG 3 LOOKING WEST ACROSS WRECKAGE OF ZK-NZP TOWARDS NORTH-WEST SHORE OF LEWIS BAY

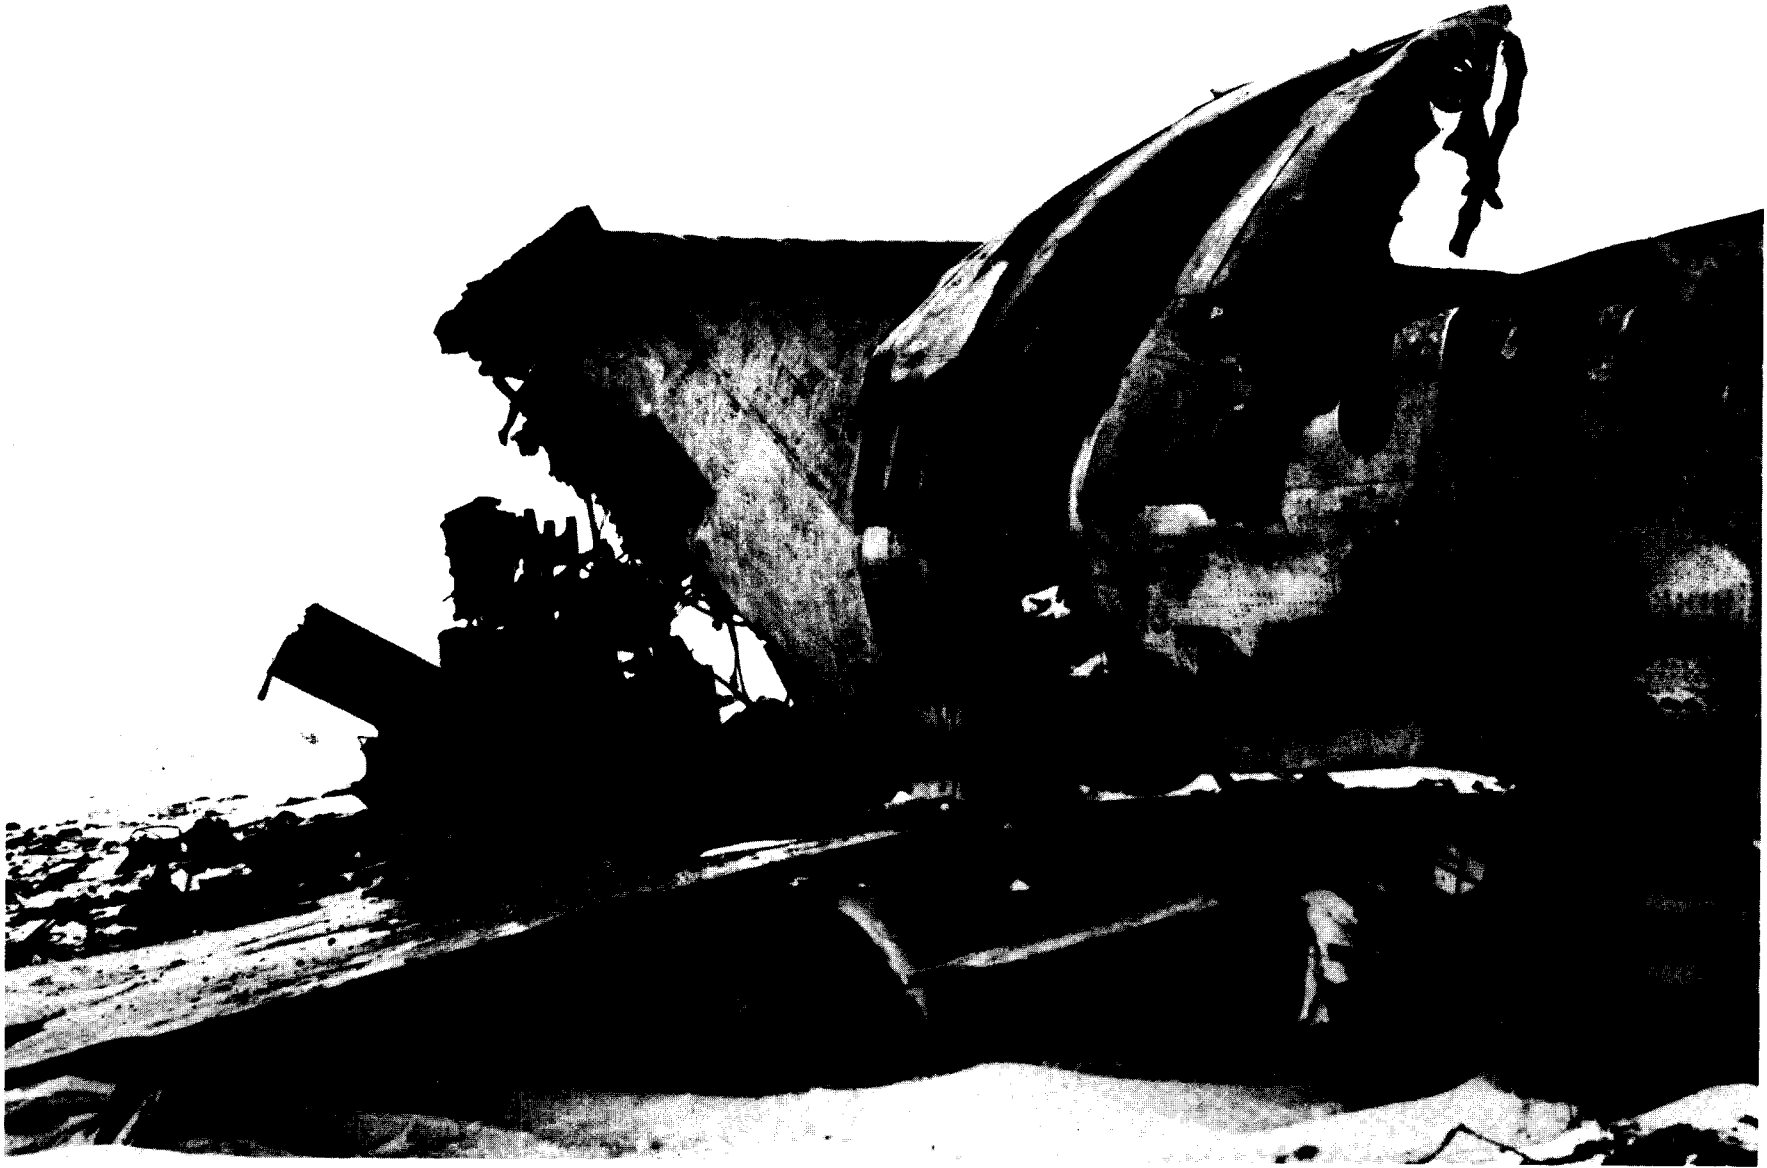
FIG 5 TOP OF RIGHT WING AND RIGHT CABIN SIDE OVER WING DOOR AREA
