Neutral Citation Number: [2015] EWCA Civ 176

**IN THE COURT OF APPEAL (CIVIL DIVISION)**  
**ON APPEAL FROM THE HIGH COURT OF JUSTICE,**  
**COMMERCIAL COURT**  
**HIS HONOUR JUDGE MACKIE QC**  
**[2013] EWHC 1568 (Comm)**

Aspen Insurance UK Limited  
- and -  
Adana Construction Limited

**Judgment**

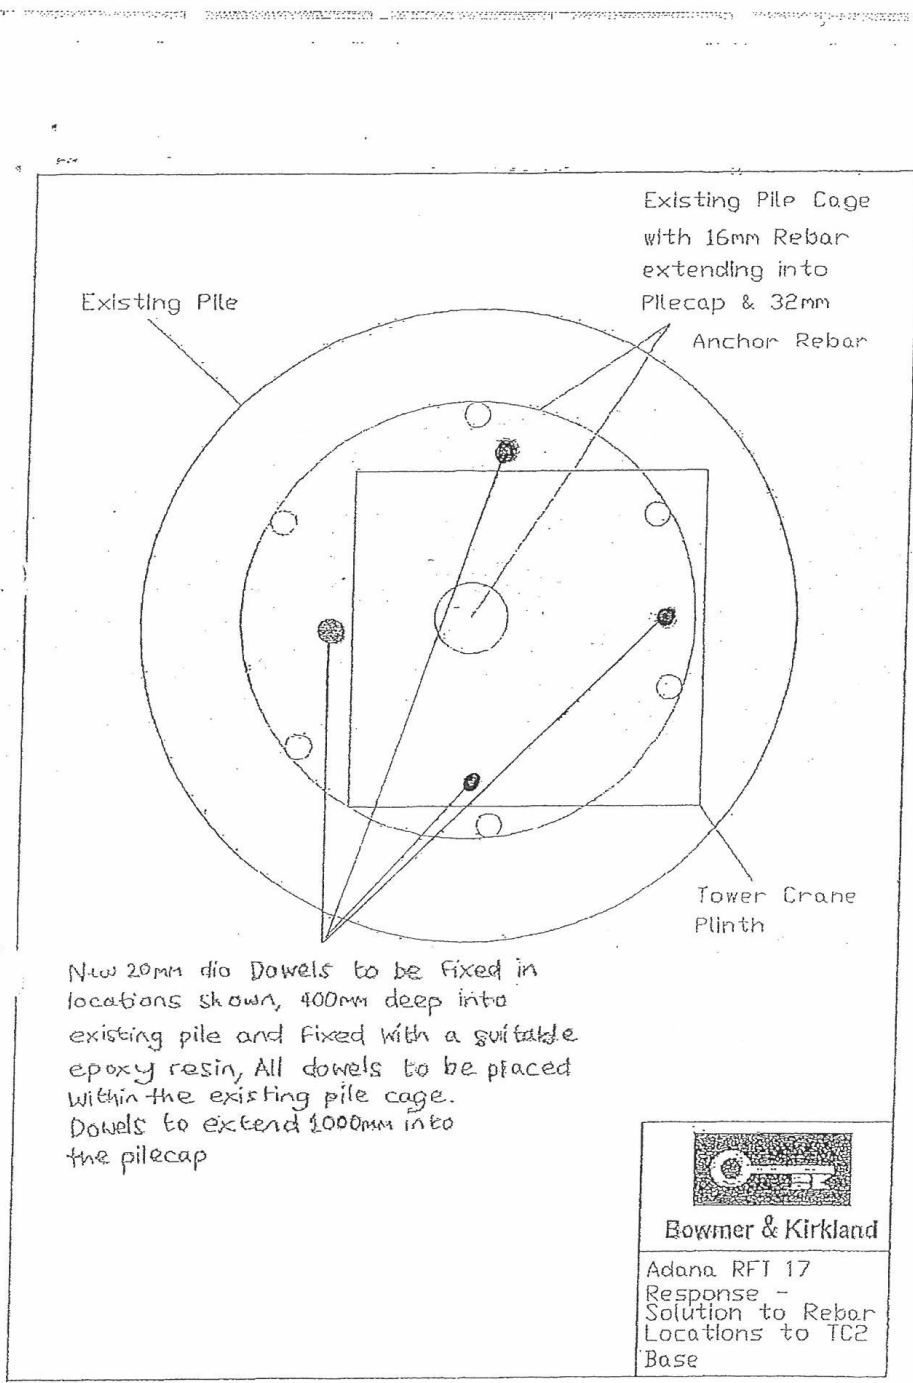
# Appendix

4. There were *in situ* when Adana began their work four reinforced piles forming the corners of a square. These had been constructed by another company called Van Elle Ltd. There had been embedded within each pile 6 x 20 mm (in diameter) high tensile reinforcing bars (“rebars”) arranged in a circle around the interior of the pile. The piles also had cast in their centre a single 32 mm rebar. The 20 mm and 32 mm rebars

protruded above the top of the piles. These rebars appear on a diagram in the Appendix to this judgment<sup>1</sup>.

<sup>1</sup> The diagram refers to 16 mm rebars but we were told that was an error.

5. The four corners of the base of the crane were to rest on the four piles at the corners of the square. For this purpose it was necessary to cut the 32 mm rebar protruding above the centre of the top of the pile, in order to accommodate the four foundation anchors of the crane. A concrete plinth was fixed on the top of each pile. On top of that there was fixed a metal strut (the “foundation anchor”), which extended upwards. A system of wire reinforcement was then superimposed; shuttering was erected; and concrete was poured in. When the concrete had set the shuttering was removed. As a result a concrete block (“the block”) was created which rested on the piles. The concrete incorporated (i) the wire reinforcement; (ii) the foundation anchors; and (iii) the 20 mm rebars insofar as they stood proud of the piles. These rebars had, themselves, to be bent back to ensure that they did not obstruct the foundation anchors.

6. The foundation anchors protruded above the top of the pile cap so as to be able to accommodate the four hollow legs of the first section of the crane which would be lowered down on top of them and secured by a bolt passing through each leg and anchor.

7. There was a further important feature. The design called for the insertion into the piles (whose 32 mm rebar had been cut off and whose 6 x 20 mm rebars had been bent back) of four 20 mm rebars (“the dowels”). Before the concrete was to be poured in Adana was to drill four holes into each pile. A dowel was to be placed in each hole to a depth of 400 mm and sufficient epoxy resin was to be placed in the hole so that, when finally placed to the depth of the hole, the dowel would be bonded to the concrete over the full surface area of the hole. The purpose of the dowels was to provide a similar tensile capacity to that of the 32 mm bar which they replaced. Their function was to provide strength, not adhesion. The dowels were to protrude upwards from the top of the pile into the pile cap/crane base for 1 metre. The effect of this was that, when the concrete was poured in, there was included within the cap/base 1 metre of each of the dowels.
