UPPER TRIBUNAL (LANDS CHAMBER)

A NOTICE OF REFERENCE UNDER THE WATER RESOURCES ACT 1991

COMPENSATION – WATER – compensation under paragraph 5(1) of Schedule 21 to the Water Resources Act 1991 - flood prevention works – whether damage caused to a house – whether water table raised – hydrology evidence

**Re: The King's Lodging,
Sandwich,
Kent, CT13 9EX**

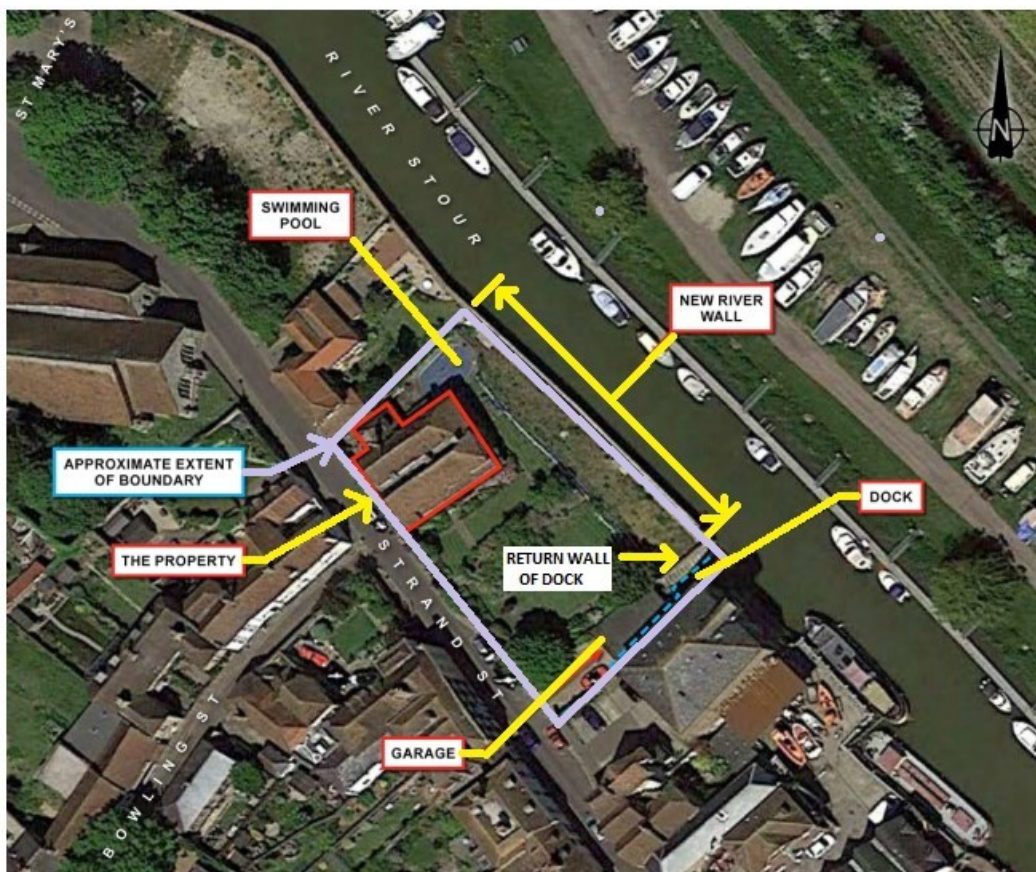
13. The following aerial photograph shows the orientation of the The King's Lodging and its garden from north-west to south-east, and shows how the river wall ends north of the eastern corner of the property; the wall on the north side of the dock is significant and we refer to it as the return wall of the dock.

24. As we saw above (paragraph 13), the riverside edge of the claimants' garden turns inwards to the dock at its southern end. The sheet piling extended along the edge of the garden but did not turn inwards along the dock return wall. The junction of new and old in that corner was to prove a major headache in the months that followed the completion of the work.

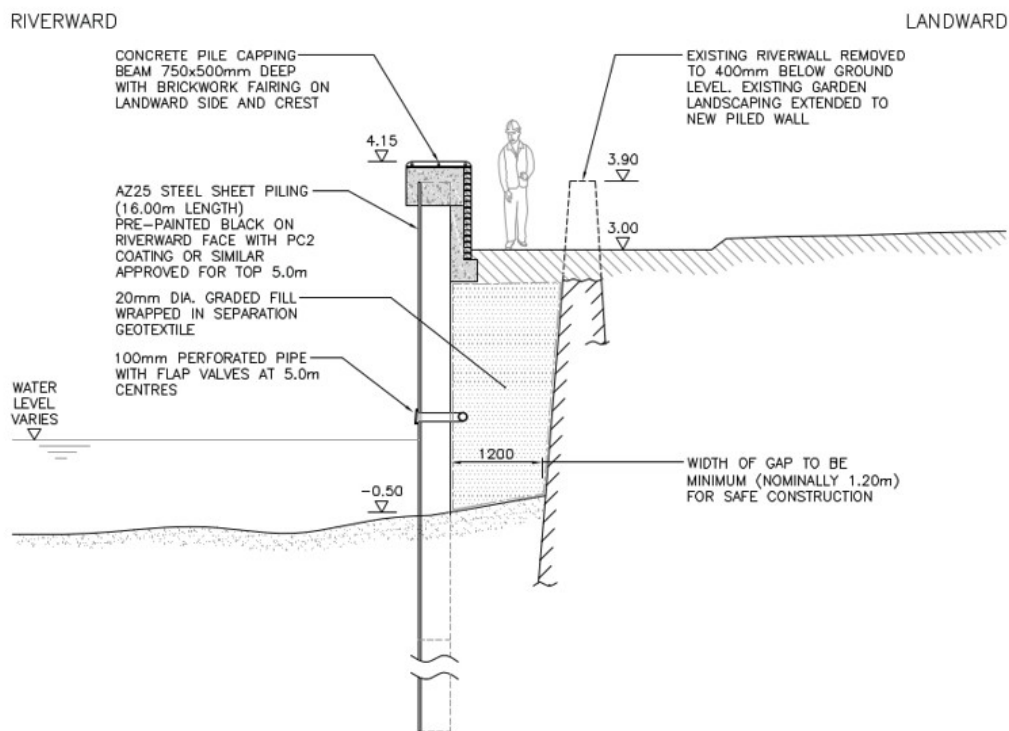
22. Below is a diagram showing the essence of the scheme in its early stages, without the concrete slab which now sits over the semi-permeable fill between the two walls.

21. The work commenced in November 2014. The new wall of steel sheet piles (SSPs) was installed about 1m outside the old wall, with a concrete wall or capping beam on top. The old wall was knocked down to below ground level, and the gap between the two walls was filled with free draining material to a depth approximately 0.75m below ground level. A 1.3m wide reinforced concrete slab or apron was added to bridge the gap between the old and new walls. This was described by Mr Jon Holland of CH2M, in his review of 19 October 2016, as a "...cut-off arrangement [is] to prevent significant seepage into the garden in the event that the free draining material does fill with water." The new wall was not intended to be impermeable and Mr Holland explained in the review "...the design aimed to retain a degree of connection, below garden level, of the tidal influence of the river with the natural groundwater regime in the garden subsoil." The clutches between the SSPs were left unsealed and flap valves were placed at intervals to ensure that water could flow out of the garden and into the river (as it was known to do through the old wall), albeit not at a rate that would cause the land to dry out. The work was completed in January 2015, save for the reinstatement of the garden. Mr Nunn explained that the river frontage at The King's Lodging is about 53m long, and so represents about 4% by length of the flood defences built as part of the scheme.
